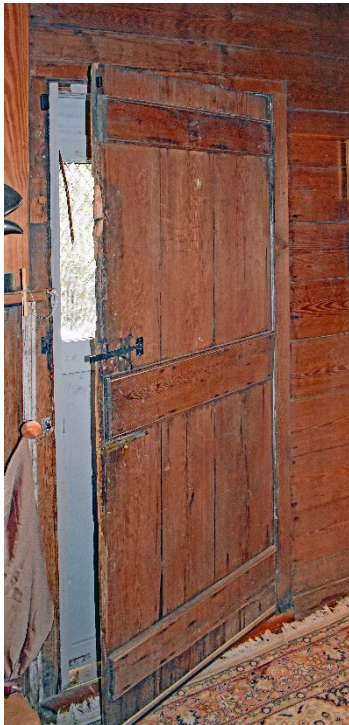
Figure 12. Batten door; south wall, south front room.

There are no raised panel doors; all the early ones are batten doors, whose horizontal battens with beaded edges are secured to the vertical boards with clinched wrought nails. There is no evidence of any H or HL side hinges that continued to be used in some rural areas into the second and third decade of the nineteenth century. Instead, all the doors were secured to their jambs by cast-iron butt hinges. The Gould House has at least four doors with pairs of hinges with one of their leaves stamped with the name of the manufacturer. The hinges used on the door on the south gable wall in the smaller front room, the ones on the door on the west wall separating the larger front room from the back center passage, and the ones on the door next to it at the bottom of the stairwell to the garret are stamped "T Clarks Com<sup>n</sup>." These sets of three-knuckle hinges with four screw holes per plate, which are mostly filled with off-set slotted screws, were made by Thomas and Charles Clark & Company at the Shakespeare Foundry in Wolverhampton, England. Established in 1795, it operated through the late nineteenth century. A fourth pair secured the closet door beneath the staircase in the smaller south front room. Those two were five-knuckle hinges with four screw holes and were labeled "T & C Clark." The precise date range of the manufacture of these two types of Clark hinges has not been established, but if so, they could provide a *terminus post quem* for the finish of the Gould House since the doors and their hinges are original. Clark saturated the American market in the nineteenth century and their stamped hinges with variations in the name and lettering have been found in buildings dating from the 1820s through the Civil War if not a few years afterward. If the hinges are useful for establishing the date of the house, the locks on the door are not since all of them are small, square cast-iron rim locks with porcelain or mineral knobs, which date to the late nineteenth or first decades of the twentieth century. Scars on most of the doors indicate that there were earlier mounted rim locks on them.

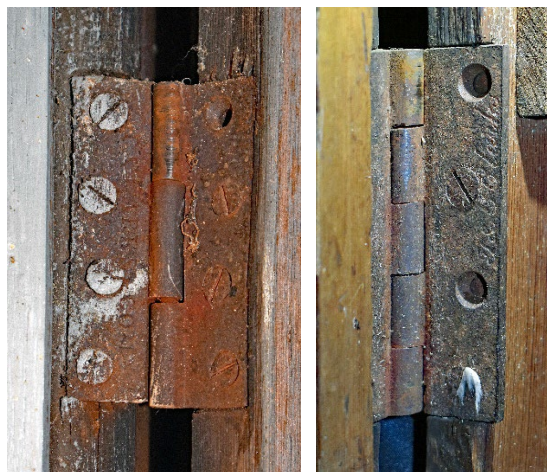
Figure 13. Left: "T Clark Comn"; Right, "T & C Clark."
